SINAMICS/SIMOTICS

Servo drive system
SINAMICS S210

SINAMICS S210 converter
SIMOTICS S-1FK2 servomotor

Operating Instructions

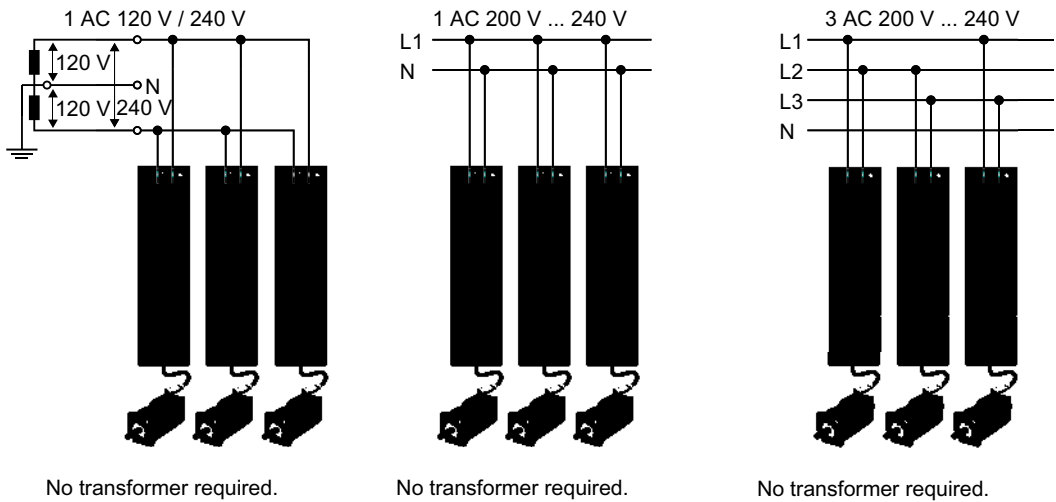
Figure 3-4 Connection options

You have the following options to supply the converter with an input voltage of 230 V.

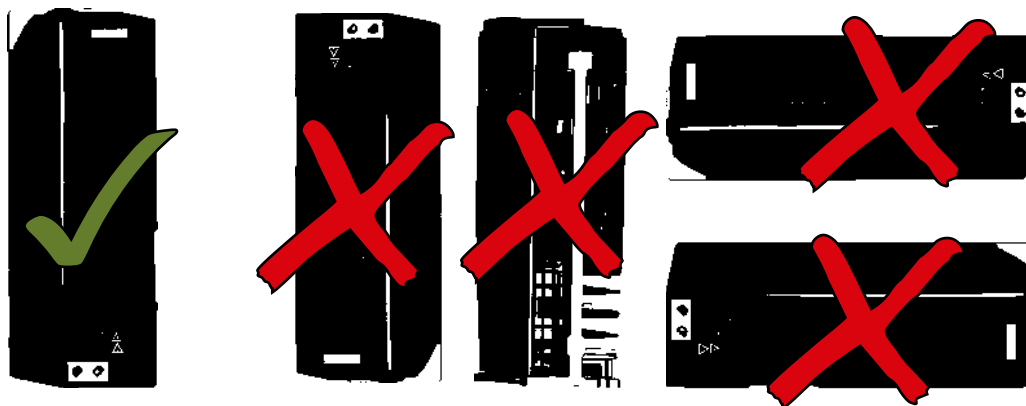
Figure 5-2 Mounting position of the converter

- Install the converter vertically with the flap for the LED display facing upwards.

- Maintain the minimum clearances to other components.
- Use the recommended hardware (screws M5) and comply with the specified torques.

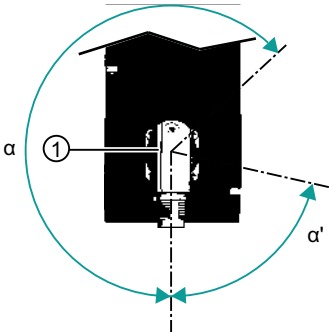
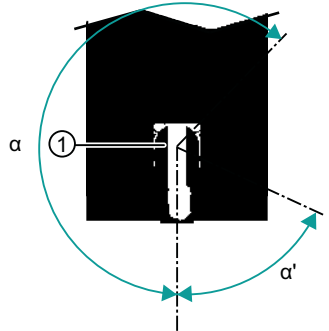
Table 5-2 Rotation range of the power connector

Motor	Angle α	Angle α'	Connector size	Drawing
1FK2□02 1FK2□03	$\leq 225^\circ$	$\leq 81^\circ$	M12

1FK2□04	$\leq 215^\circ$	$\leq 75^\circ$	M17

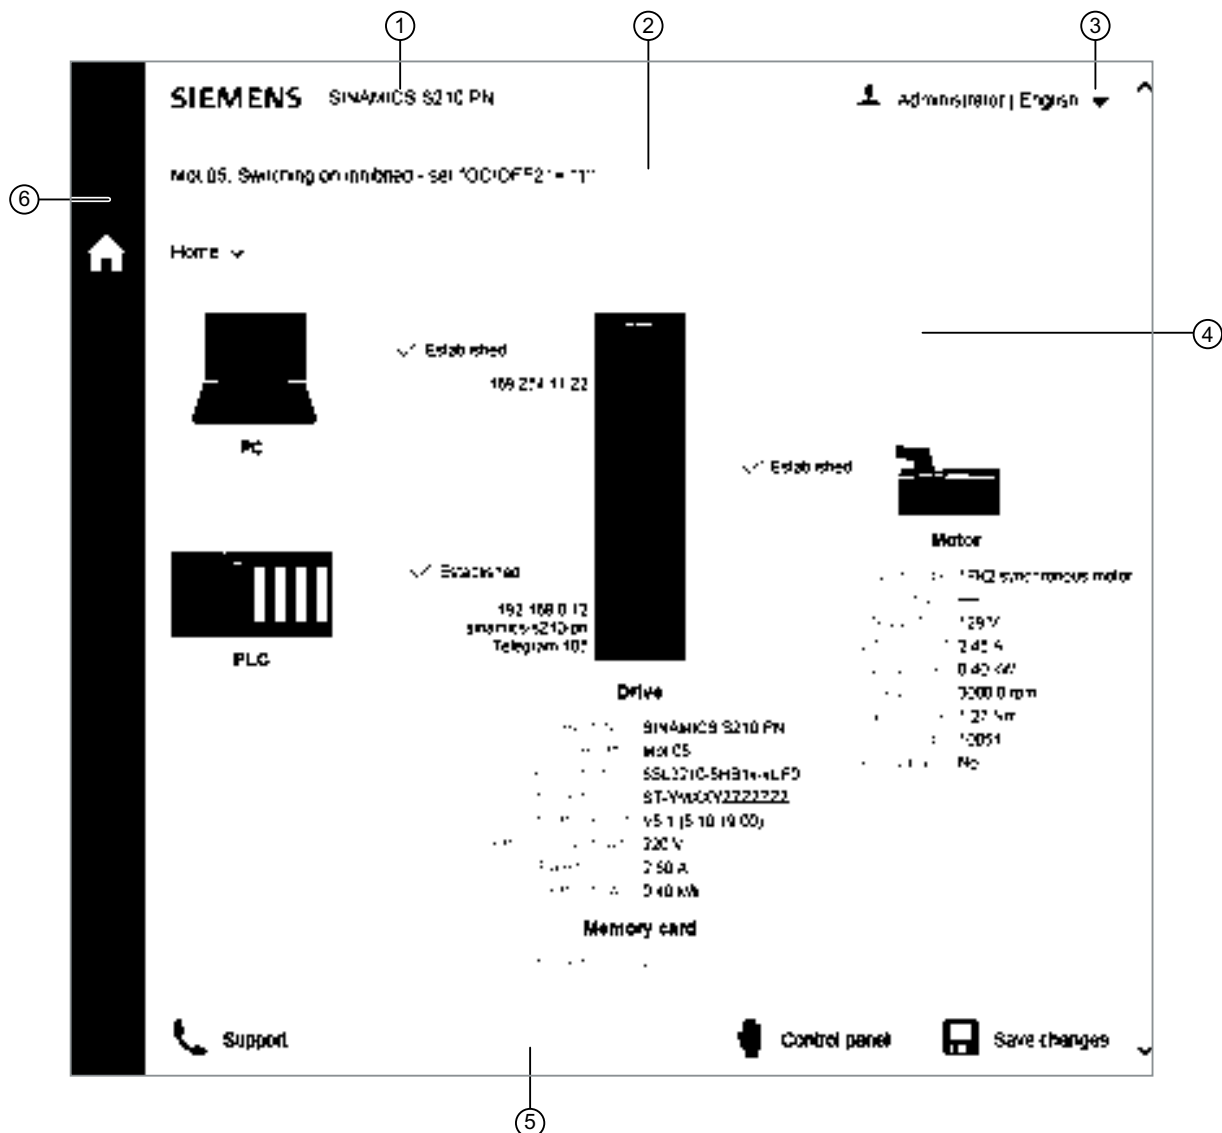
Figure 6-2 Basic structure of the web server

- ① Device designation
- ② Status bar (from left to right):
Name of the converter (if entered) / Status of the converter / Fault and warning messages
- ③ Drop-down list for the language selection and to log out from the web server.
Displays the logged-in user and the set language
- ④ Active view of the web server (in the example: Start page after the user has logged in)
- ⑤ Action bar (from left to right):
Support information / Call control panel / Save retentively (RAM to ROM)
- ⑥ Navigation toolbar (see following "Navigation of the web server")

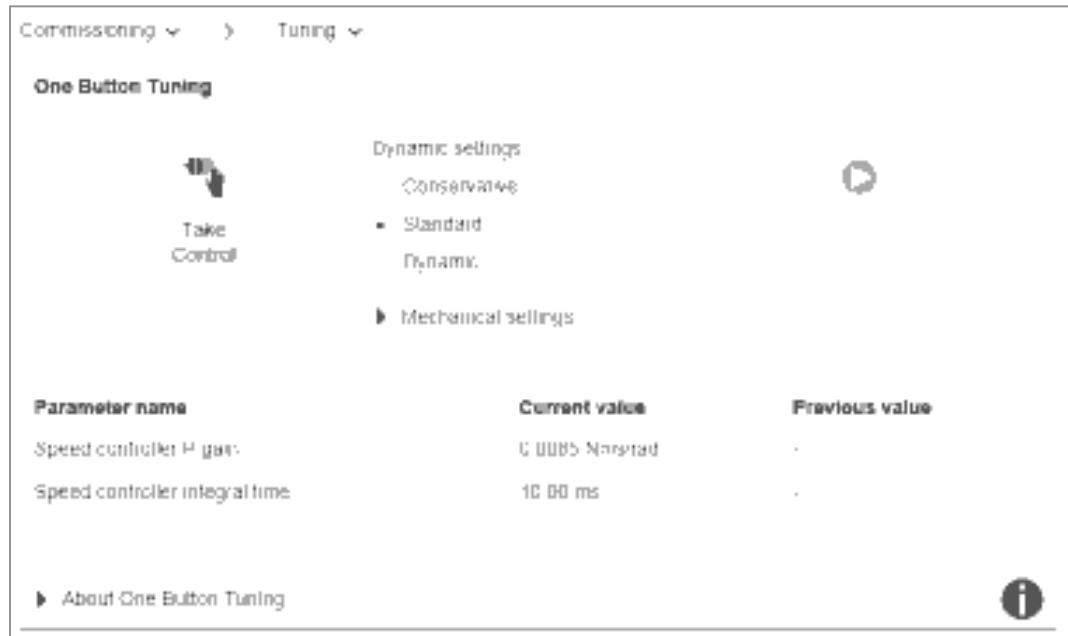
Figure 6-6 View before performing the One Button Tuning

2. Click "Take Control".
Confirm the "Activate master control" prompt.
The master control is indicated by a broken orange bar.
3. Select the desired dynamic response setting for the One Button Tuning corresponding to the mechanical system of your machine.
One Button Tuning optimizes the drive based on the selected dynamic response setting.
 - "Conservative":
Slow control – low mechanical load.
 - "Standard":
Best compromise between fast speed control and low mechanical load.
 - "Dynamic":
Fast speed control – high mechanical load.

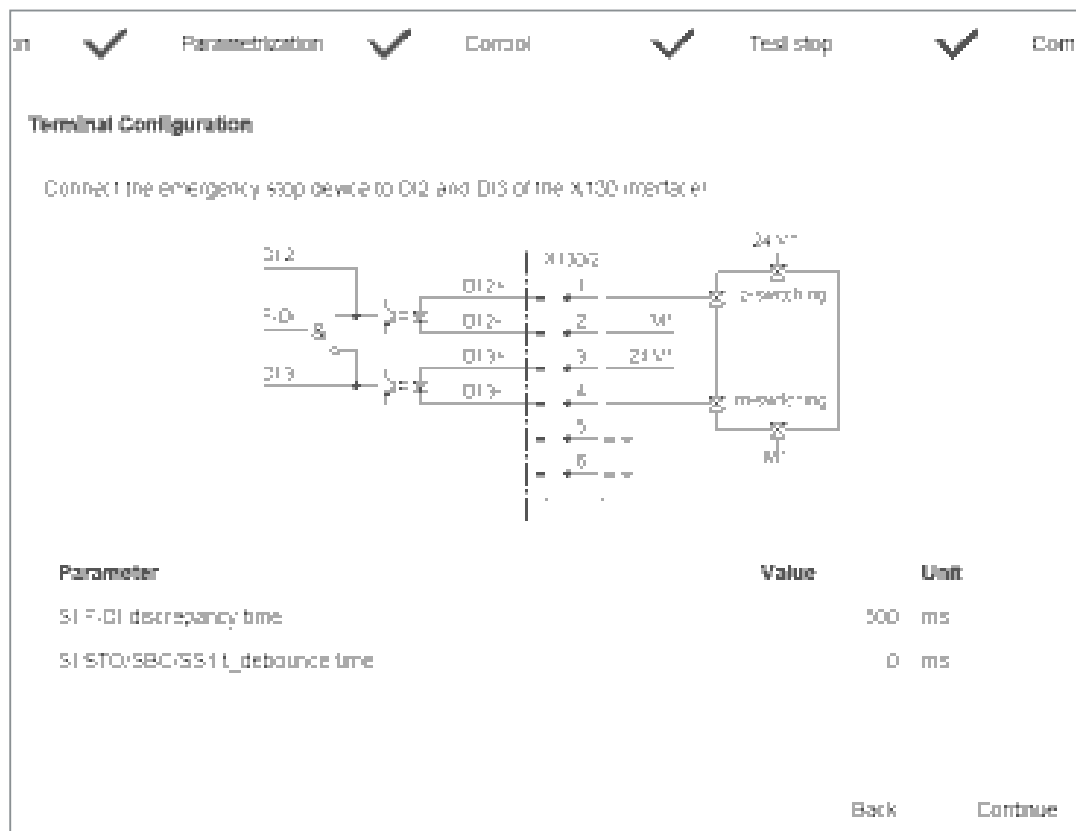
Figure 6-24 Parameterizing the controller via terminals

The signal states at the two terminals of an F-DI are monitored in order to determine whether these have assumed the same logical state within the discrepancy time (unavoidable time delay). The selection and deselection must be performed in both monitoring channels within this discrepancy time.

The discrepancy time and the debounce time are pre-assigned default values and do not have to be changed in most cases. See the following figure.

1. If you want to change the discrepancy time, click the "SI F-DI discrepancy time" field.
An input dialog with the same name opens. Adjust the set discrepancy time and confirm with "OK".
2. If you want to change the debounce time, click the "SI STO/SS1 debounce time" field.
An input dialog with the same name opens. Set the debounce time and confirm with "OK".
3. Click "Continue".
The "Test stop" commissioning step is activated.

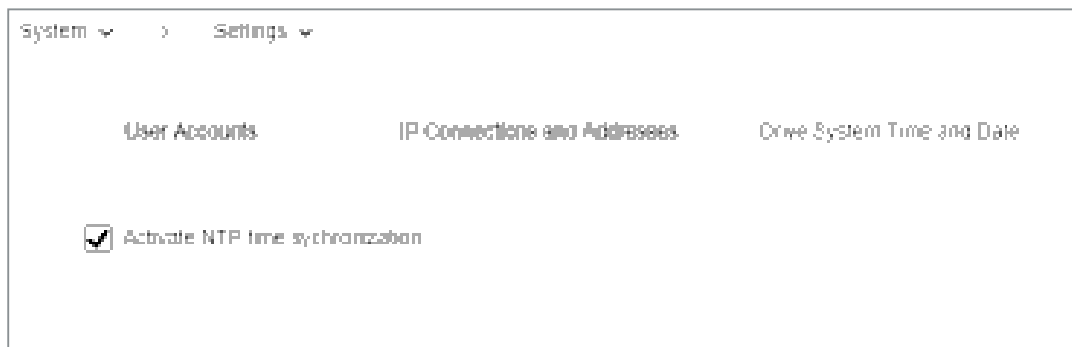
Figure 6-36 System time

3. Deactivate/activate "Activate NTP time synchronization".
4. Click "Apply Settings" to save the changes in the RAM of the device.
5. Click

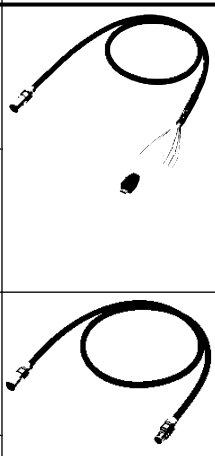
Table 8-9 MOTION-CONNECT OCC cable with SPEED-CONNECT connector

Designation and use	Cable type	Connector size	Outer diameter	Minimum bending radius, static	For connection to motor	Article number ¹⁾
			D_{max} / mm	R / mm		
Motor connection cable MC500 OCC for predominantly fixed installation

M12	9.7	23.5	1FK2□02 1FK2□03	6FX5002-8QN04-□□□□
		M17	10.5	25.5	1FK2□04	6FX5002-8QN08-□□□□
Motor connection cable MC800 OCC for use in a cable carrier		M12	9.7	28.2	1FK2□02 1FK2□03	6FX8002-8QN04-□□□□
		M17	10.5	30.6	1FK2□04	6FX8002-8QN08-□□□□
Extension cable MC500 OCC for predominantly fixed installation

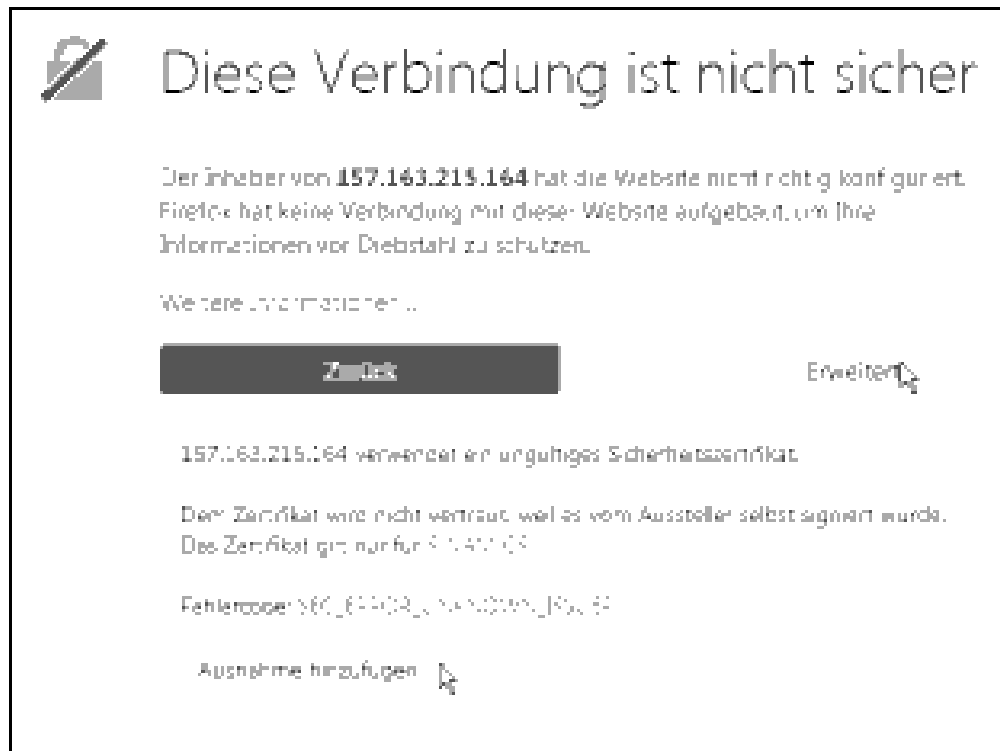
Figure A-3 Mozilla

1. Click "Extended".
The information for the security certificate is displayed.
2. Click "Add exception" in order to be able to communicate via a secure HTTPS connection.
